# SMT Troubleshooting Guide

Easy-to-use advice  
for common SMT  
assembly issues.

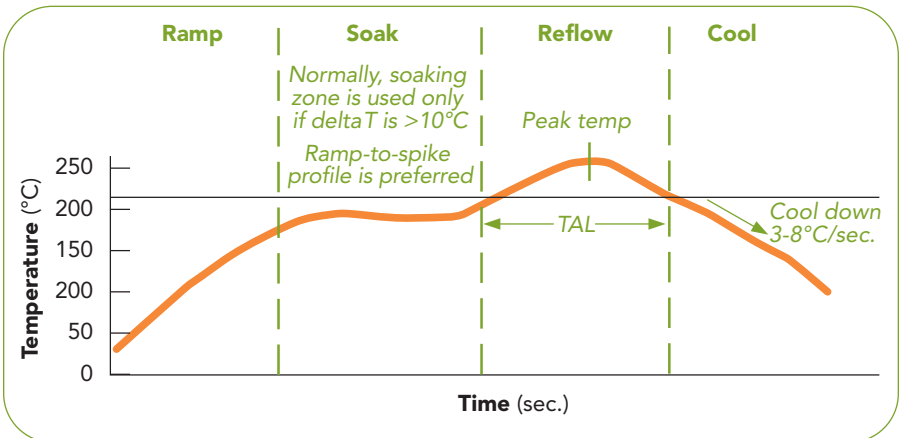
Ramp-to-spike profile

Description	Recommendations
<p>Extended soak will input more heat to the paste and result in paste hot slump phenomenon.</p>	<p>Adopt a straight ramp to spike profile, without soak zone if possible.</p>
